# **Preliminary report** Crash involving Malaysia Airlines Boeing 777-200 flight MH17

Hrabove, Ukraine - 17 July 2014

*The Hague, September 2014*

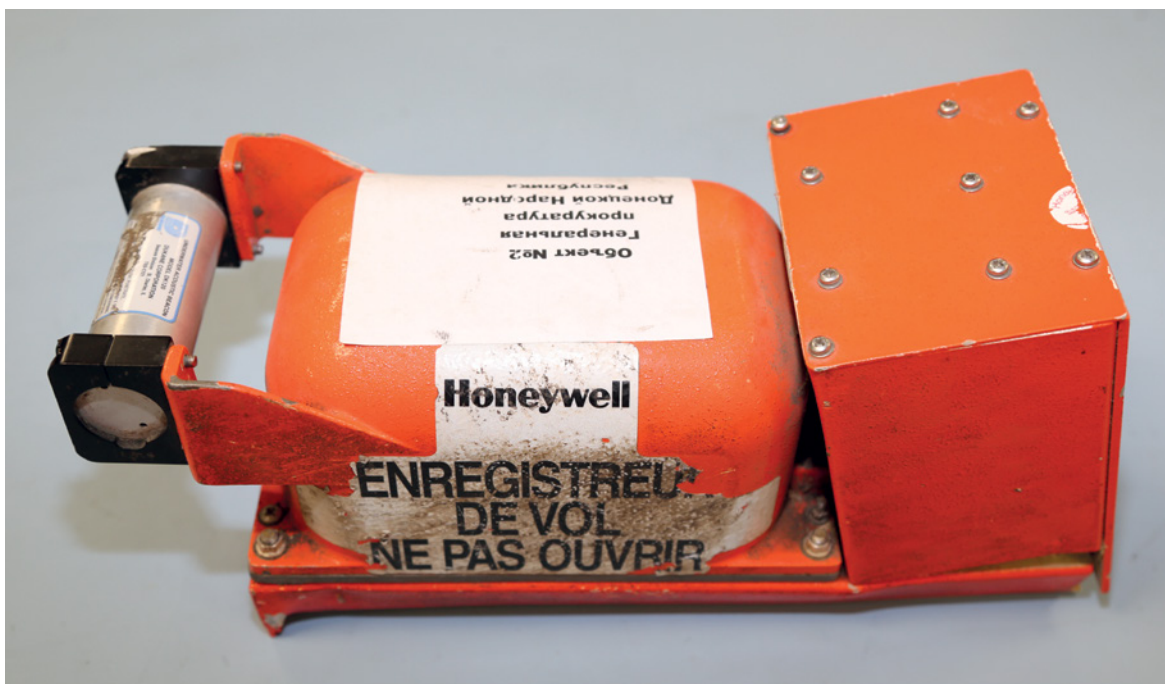
The housing of the CVR (figure 4) had been damaged and, although the model and serial numbers were unreadable on the data plate, the serial number 1366 - matching the one provided by Malaysia Airlines - was found stamped on the underside of the chassis. The external damage found on the CVR is consistent with impact damage, the internal memory module was intact. The recording capacity of this recorder is 30 minutes.

The full 30 minutes were successfully downloaded and contained valid data from the flight.

Figure 4: Cockpit voice recorder. (Source: AAIB)

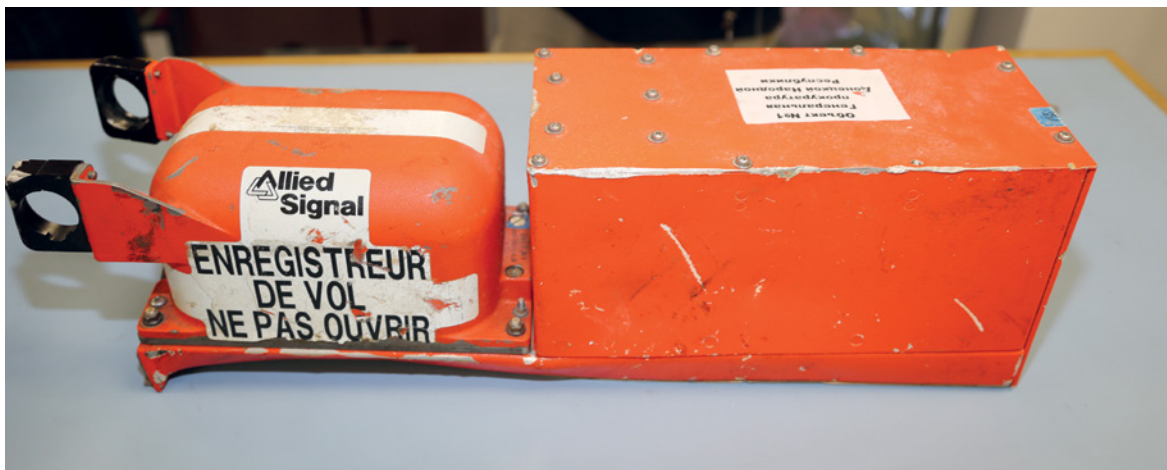
The label on the housing of the FDR (figure 5) showed that it was Allied Signal Model Number 980-4700-003 with Serial Number 2196. These details matched the details provided by Malaysia Airlines. The recorder was found damaged but the internal memory module was intact. The external damage found on the FDR was consistent with impact damage. The FDR, which can record 25 hours of operational data, was successfully downloaded and contained valid data from the occurrence flight.

Figure 5: Flight data recorder. (Source: AAIB)

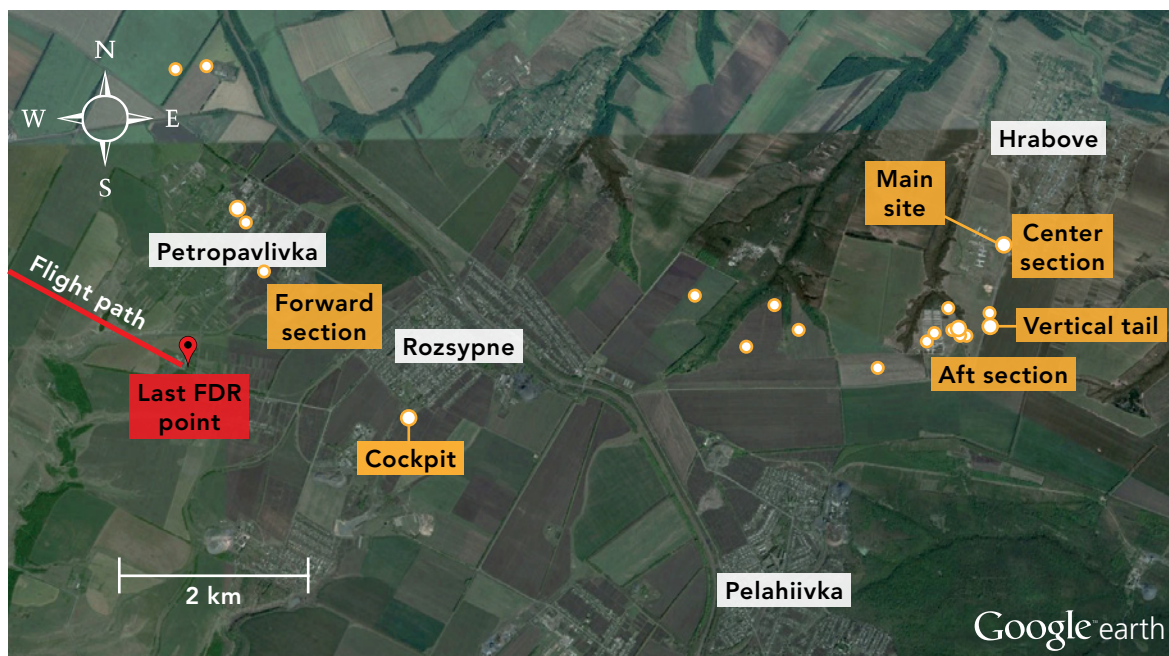
The aircraft wreckage, identified from the on-site photographs and satellite images, consisted of many large and small pieces distributed over an area of approximately 10 km by 5 km (figure 6). Fuselage pieces, cargo and baggage were scattered throughout the wreckage site. There were many additional unidentified pieces that are not shown in the figure. For easy reference the wreckage site has been divided into sections as shown in figure 6. These sections match with the aircraft sections shown in figure 7.

Figure 6: The last location of the aircraft in flight taken from the FDR. Wreckage distribution is grouped per section of the aircraft (Source: Google Earth, wreckage information Dutch Safety Board).

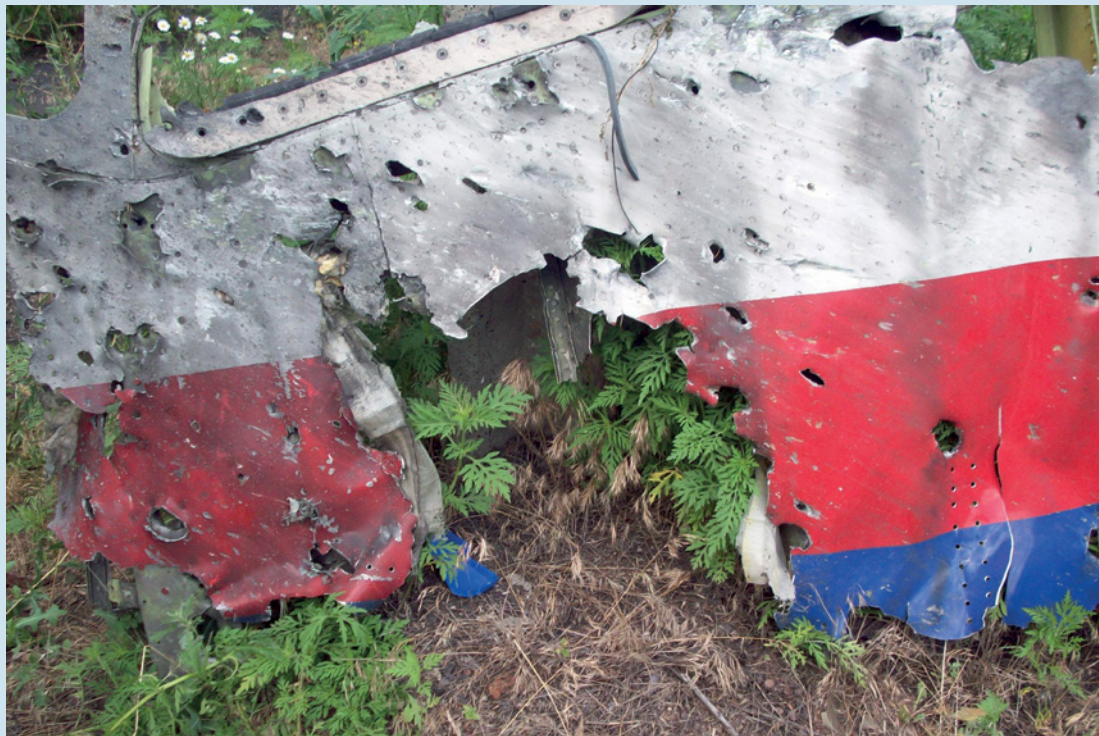
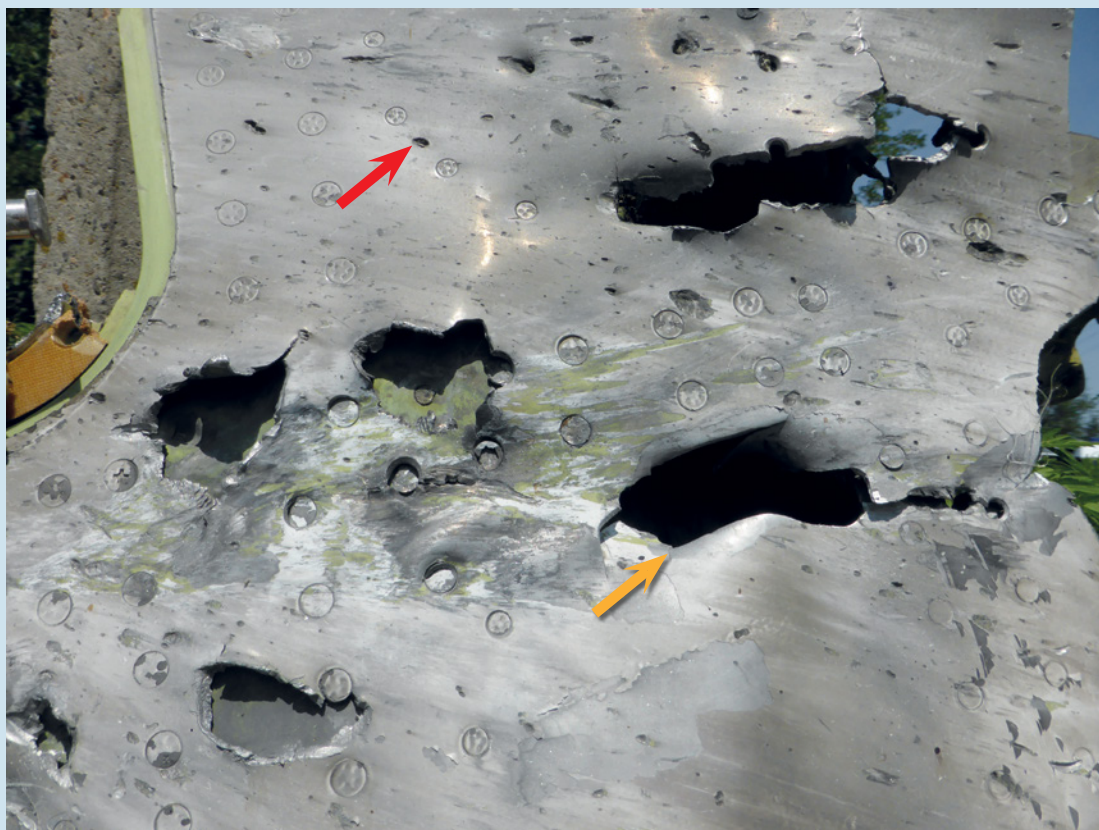
Photographs from the some wreckage showed that a number of pieces contained multiple holes and indentations. An example of a piece of wreckage containing such damage was a piece of skin from below the left cockpit window (figure 8) found in the town of Petropavlivka.

Figure 8: Forward fuselage skin from below the left cockpit window containing numerous small holes and indentations (above); enlarged image of the right upper corner of this skin (below) showing puncture holes (orange arrow) and pitting (red arrow). (Source: DCA and AFP)

Noting that the investigation team has not yet had the opportunity to recover these components for forensic examination, photographs from the wreckage indicated that the material around the holes was deformed in a manner consistent with being punctured by high-energy objects. The characteristics of the material deformation around the puncture holes appear to indicate that the objects originated from outside the fuselage.

The pattern of damage observed in the forward fuselage and cockpit section of the aircraft was consistent with the damage that would be expected from a large number of high-energy objects that penetrated the aircraft from outside.

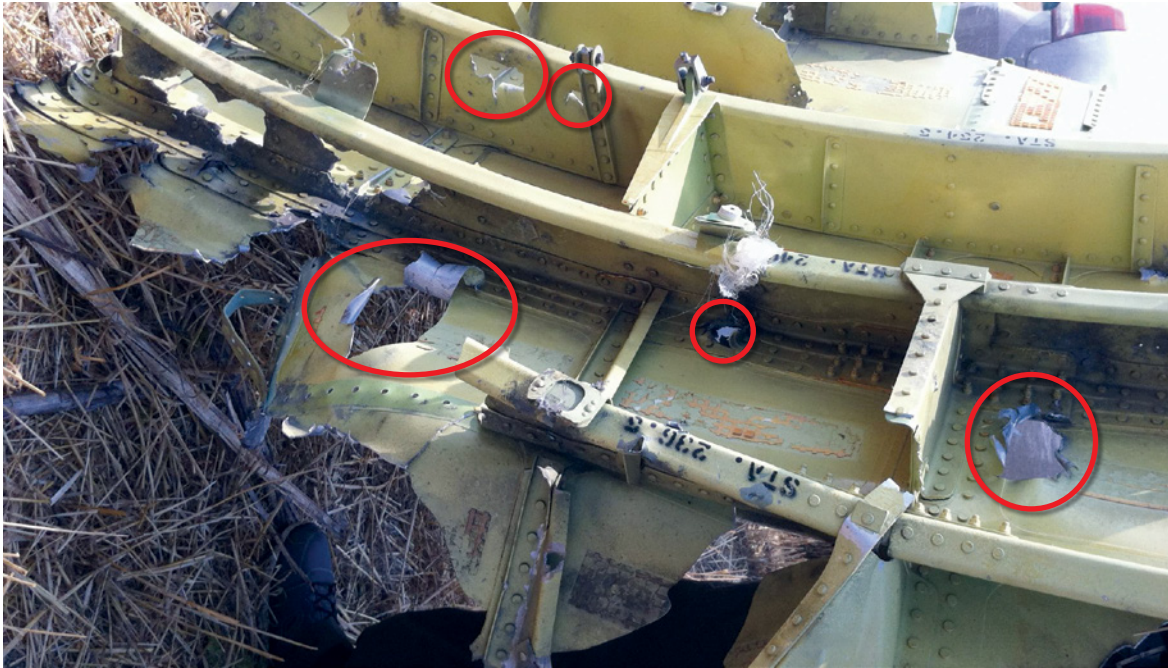
Around 1.7 km north of the position where the cockpit window structure was found, was a section of the cockpit roof also showing holes indicating penetration from outside (figure 9).

Figure 9: Part of the inside cockpit roof, indicating penetration with objects from outside. (Source: DCA)

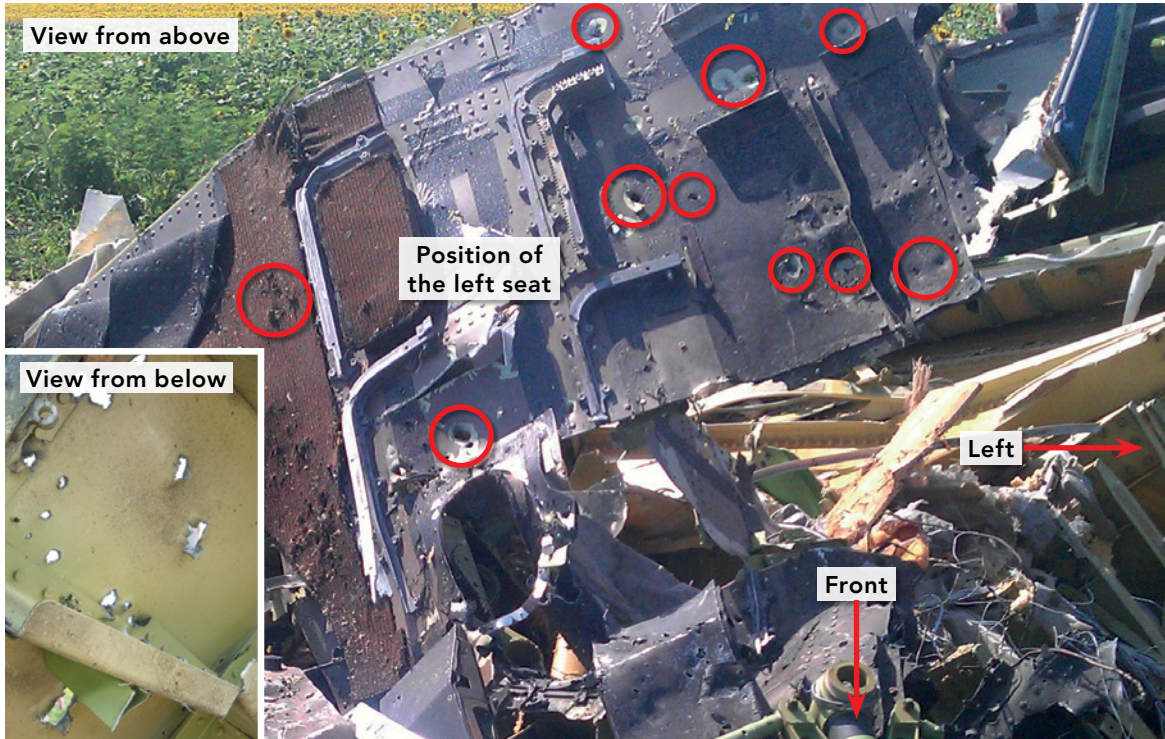
Puncture holes identified in images of the cockpit floor suggested that small objects entered from above the level of the cockpit floor (figure 10).

Figure 10: Cockpit floor with floor parts showing puncture holes (red circles) coming from above the floor.  
(Source: NBAAI)

Detailed examination of the structural damage is ongoing. Forensic examination will be performed if the wreckage can be recovered,

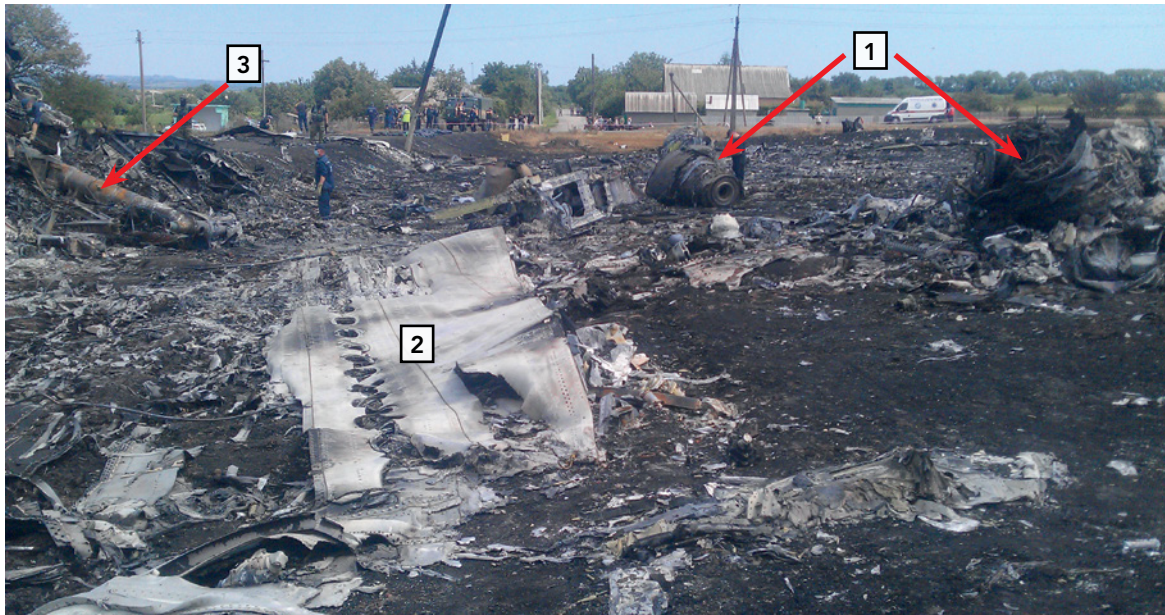
The main site was located at the south-western corner of the town of Hrabove, 8.5 km from the last recorded FDR position of the aircraft. This site contained parts of the wings, both engines, the main landing gear and a portion of the fuselage (figure 11). Aircraft parts distributed over the main site had been subjected to post crash fire.

Figure 11: Main wreckage site showing engine parts (1), wing with inspection hatches (2) and main landing gear (3). (Source: NBAAI)

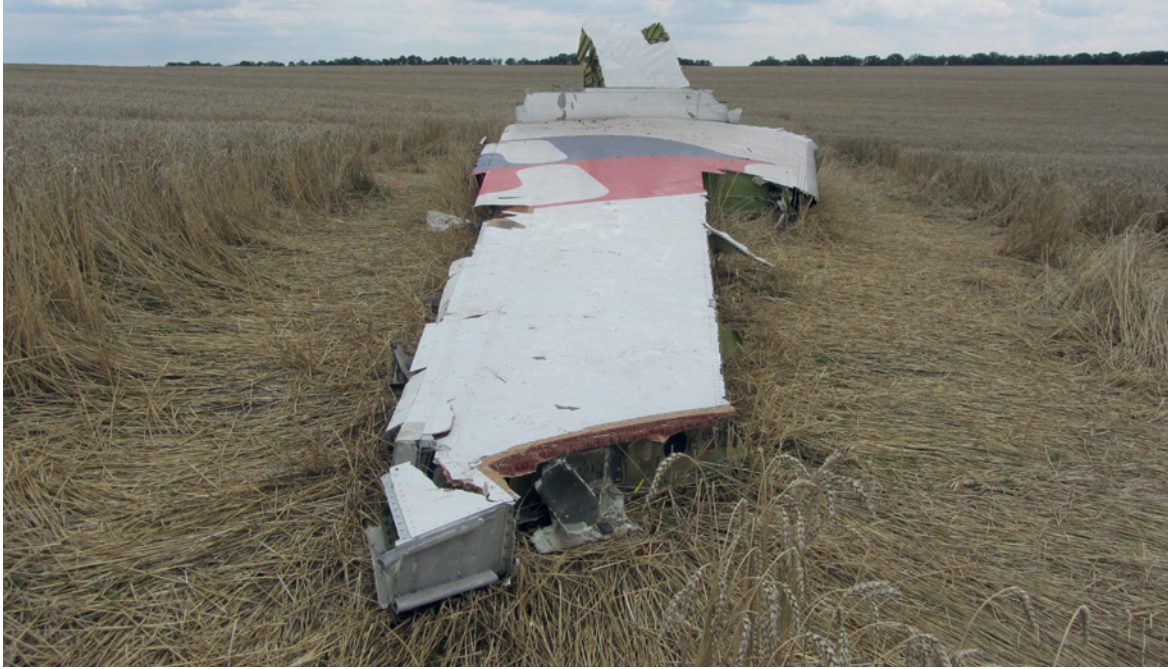
The vertical tail (figure 12) was located in a field to the south of Hrabove, approximately 8 km from the last recorded FDR position. The vertical tail was still attached to a portion of the upper rear fuselage. The rudder and a portion of the vertical tail's leading edge were not attached. The remains of the rear fuselage, horizontal stabiliser centre section, and items from the cabin were found about 100 metres north of the vertical tail.

Figure 12: Vertical tail. (Source: DCA)

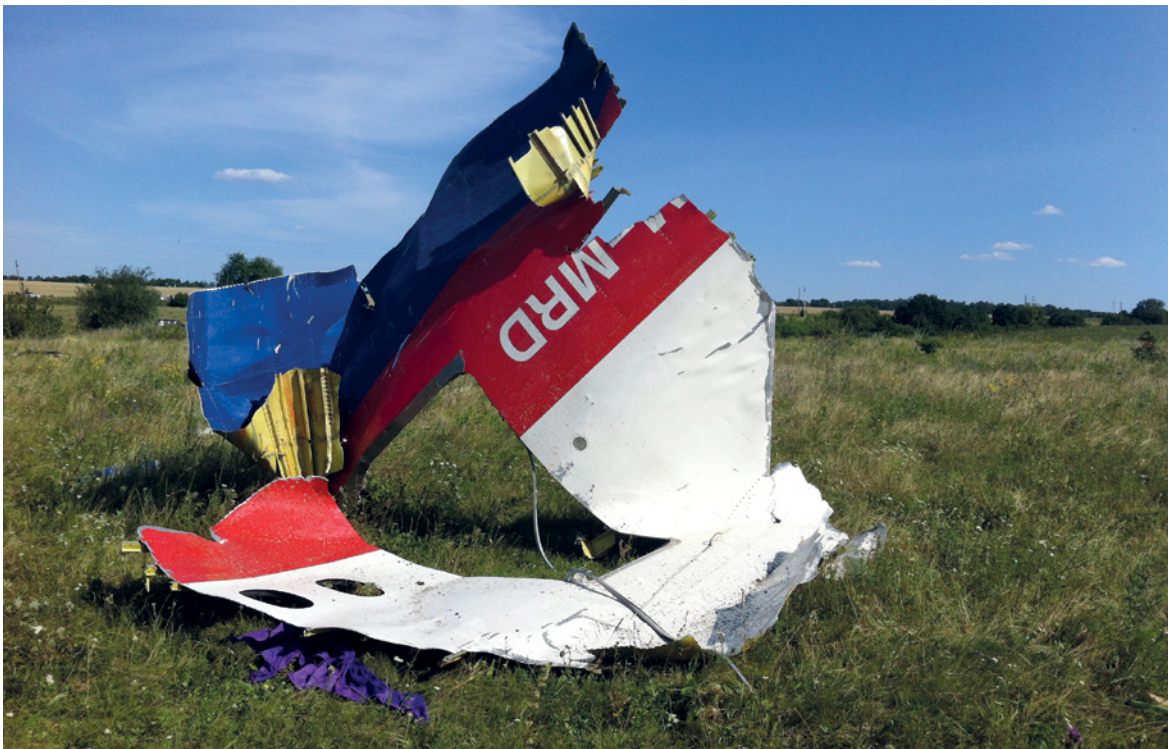
A section of aft fuselage skin from the right side (figure 13) was located 330 metres west of the vertical tail, and the left wing tip and right horizontal stabilizer were also in this location. The left horizontal stabilizer was found another 330 metres to the west.

Figure 13: Aft fuselage skin, right side, with partial registration of the aircraft. (Source: NBAAI)
