# **Preliminary report** Crash involving Malaysia Airlines Boeing 777-200 flight MH17

Hrabove, Ukraine - 17 July 2014

*The Hague, September 2014*

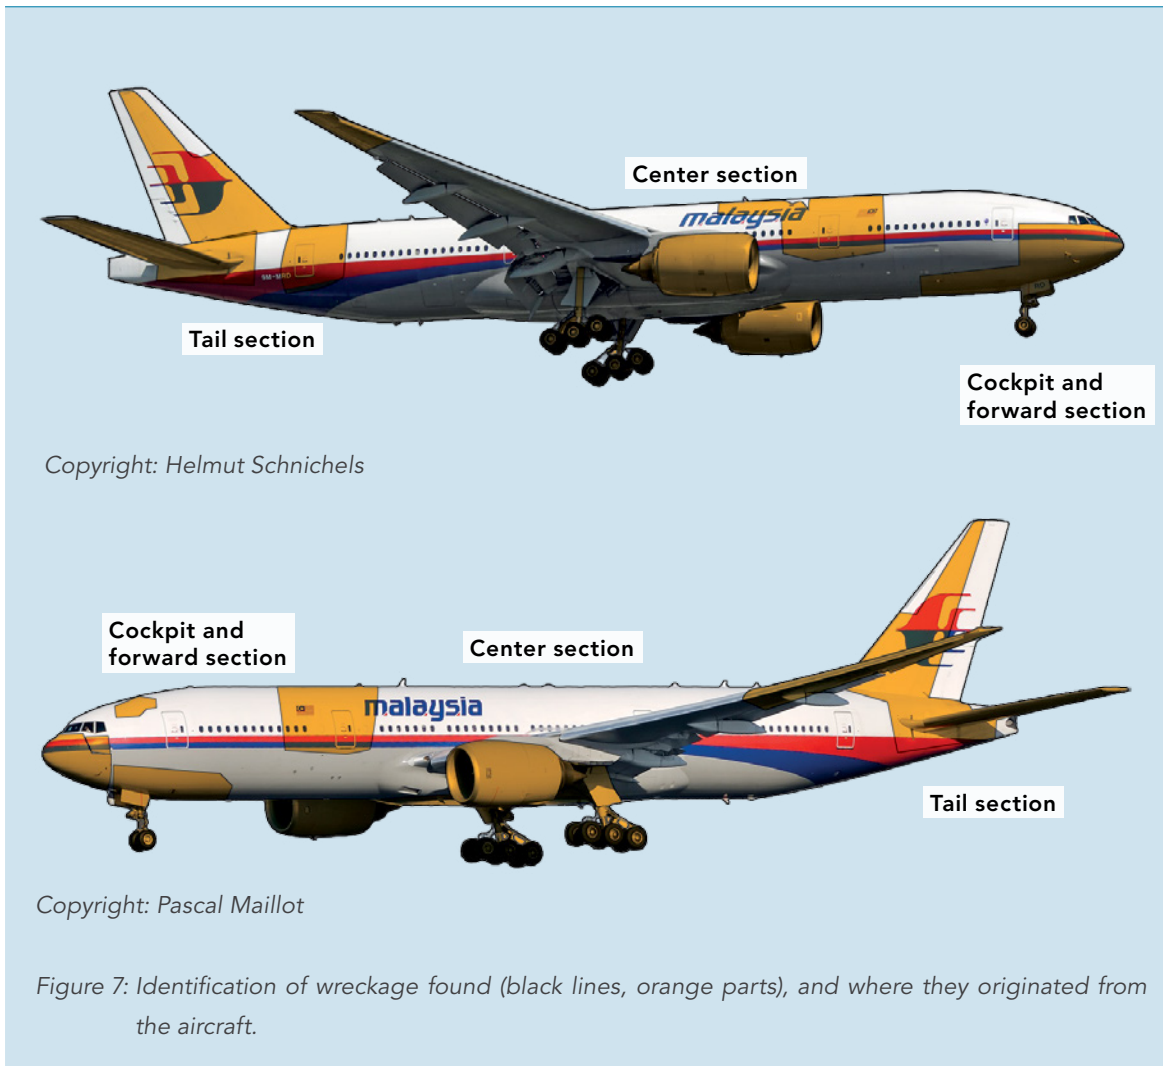
The aircraft wreckage, identified from the on-site photographs and satellite images, consisted of many large and small pieces distributed over an area of approximately 10 km by 5 km (figure 6). Fuselage pieces, cargo and baggage were scattered throughout the wreckage site. There were many additional unidentified pieces that are not shown in the figure. For easy reference the wreckage site has been divided into sections as shown in figure 6. These sections match with the aircraft sections shown in figure 7.

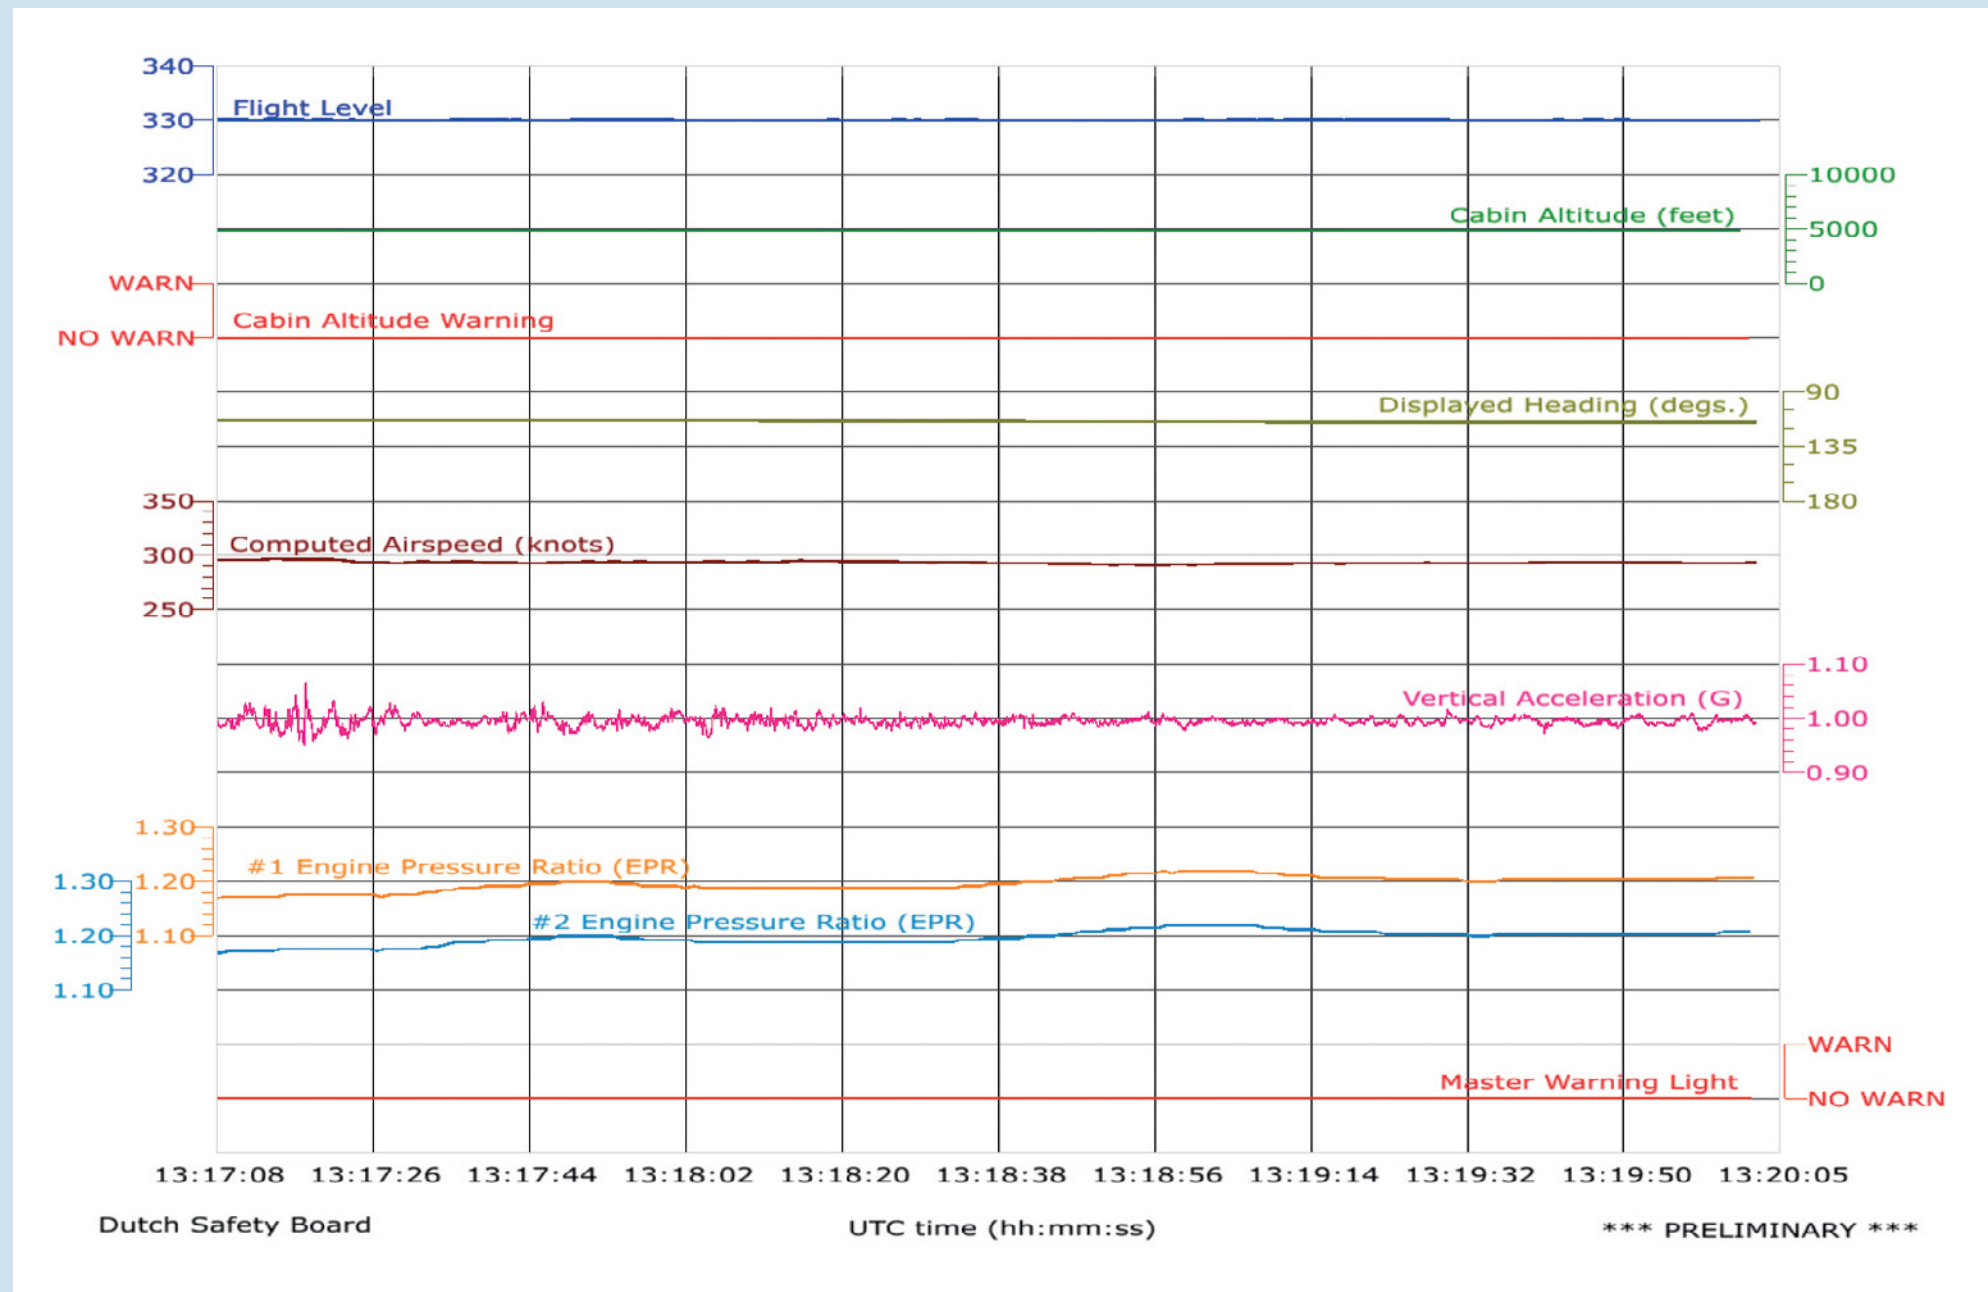
PRELIMINARY FDR DATA

The sampling rate of the various parameters displayed, vary from 8 times per second to once per 4 seconds. This explains why not all lines end at the same moment. Shown between brackets below, are the sampling rates of the various parameters.
